ACCIDENT TO PAN-AM BOEING 747 N739PA AT LOCKERBIE ON 21 DECEMBER 1988

Baggage Container Examination

P T Claiden

April 1989

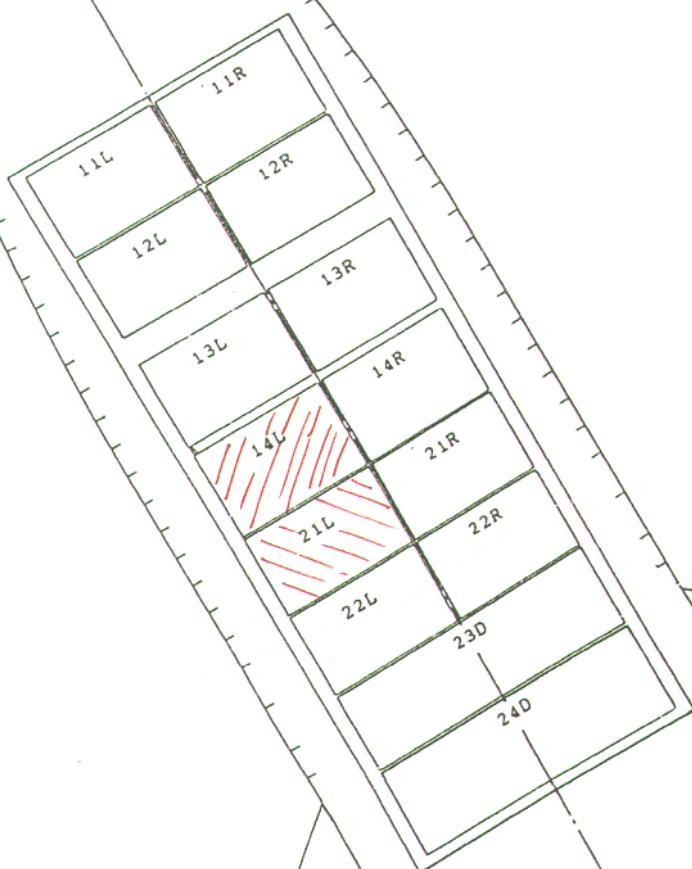
BAGGAGE CONTAINER IDENTIFICATION AND LOCATION
FORWARD CARGO HOLD

Information supplied by Pan Am showed that this aircraft had been loaded with 12 baggage containers and two cargo pallets in the forward hold. The stated identification and position of each container is shown in figure 1.

11L - AVA 2074 XT
12L - AVE 1721 PA
13L - AVN 8372 PA
14L - AVE 4041 PA
21L - AVN 7511 PA
22L - AVE 2360 PA

11R - AVE 3146 PA
12R - AVE 3929 PA
13R - AVE 9401 PA
14R - AVE 9621 PA
21R - AVE 4159 PA
22R - AVE 9394 PA
23D - Pallet PLP 0277 PAA
24D - Pallet PLP 0348 PAA

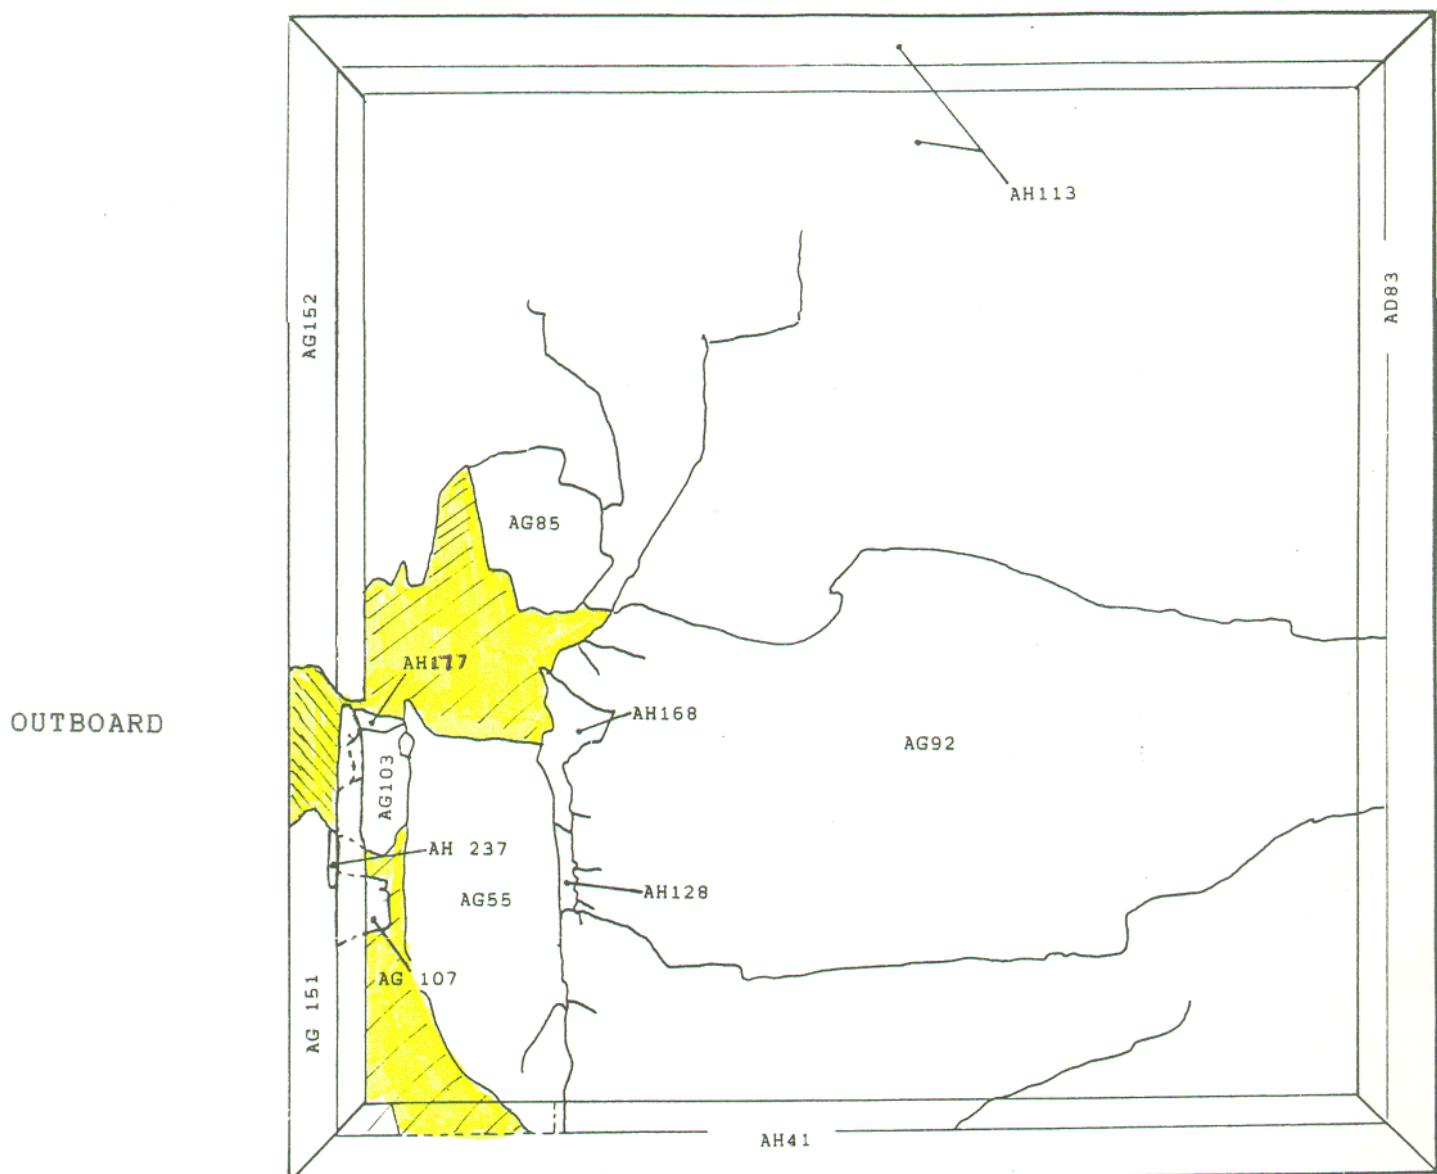
AD83 Inboard side floor edge member

AG55 Dished floor panel section

AG85 Heavily distorted floor panel section

AG92 Floor panel section, distorted at outer edge

AG103 Distorted floor panel fragment

AH41 Aft floor edge member

AH113 Floor panel section attached to fwd edge member

AH177 Distorted floor panel fragment

AH128 Distorted floor panel fragment

AH168 Distorted floor panel fragment

AG 152 Forward section of blast damaged outboard edge member

AG 151 Aft section of blast damaged outboard edge member

AH 237 Blast damaged fragment from AG 151

AG 107 Floor fragment associated with AG 151

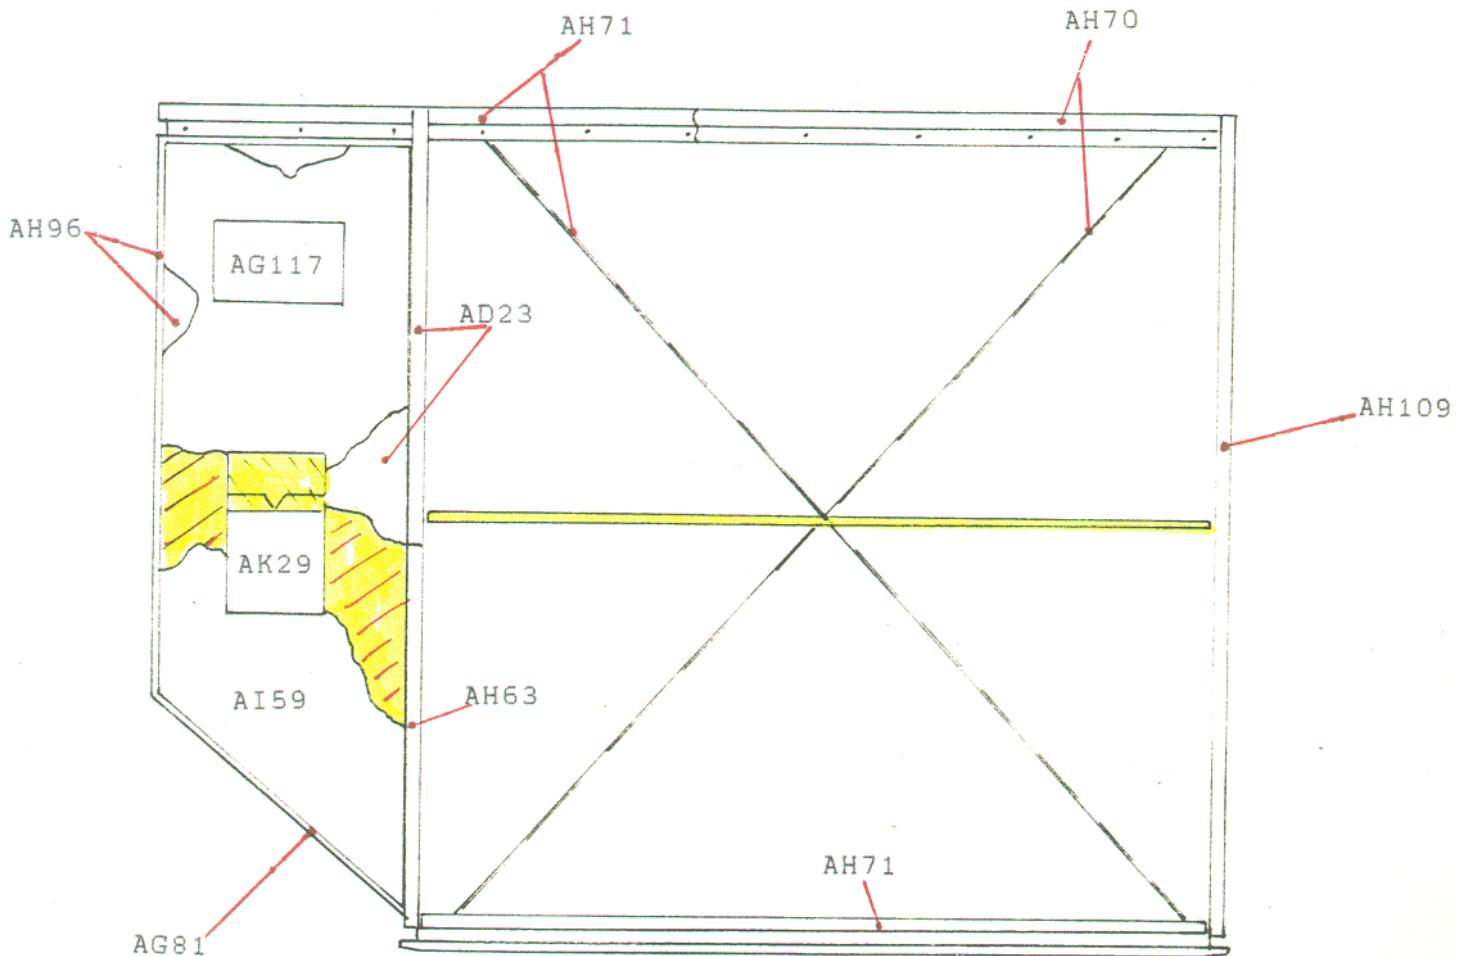
FIGURE 3.2

AD23 Curtain apperture left side vertical edge member, upper half

AG81 Sloping face edge member

AG117 Container manufacturers data plate containing AG145, burnt piece of material which itself contained a fragment of circuit board

AH63 Curtain apperture left side vertical edge member, lower half

AH70 Upper edge member, right half, attached to roof edge member and one curtain wire

AH71 Upper edge member, left half, attached to roof edge member, curtain wire and lower curtain bar

AH96 Left edge vertical member

AH109 Curtain apperture right side vertical member

AI59 Left side lower skin section adjoining sloping face

AK29 Soot stained plastic sheet (provisionally thought to have come from AVE 4041 PA)

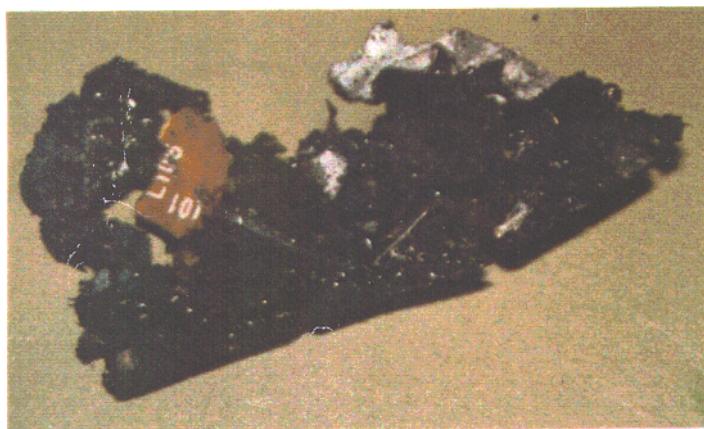
AG145 Showing fragment of circuit board
Approx 2X full size

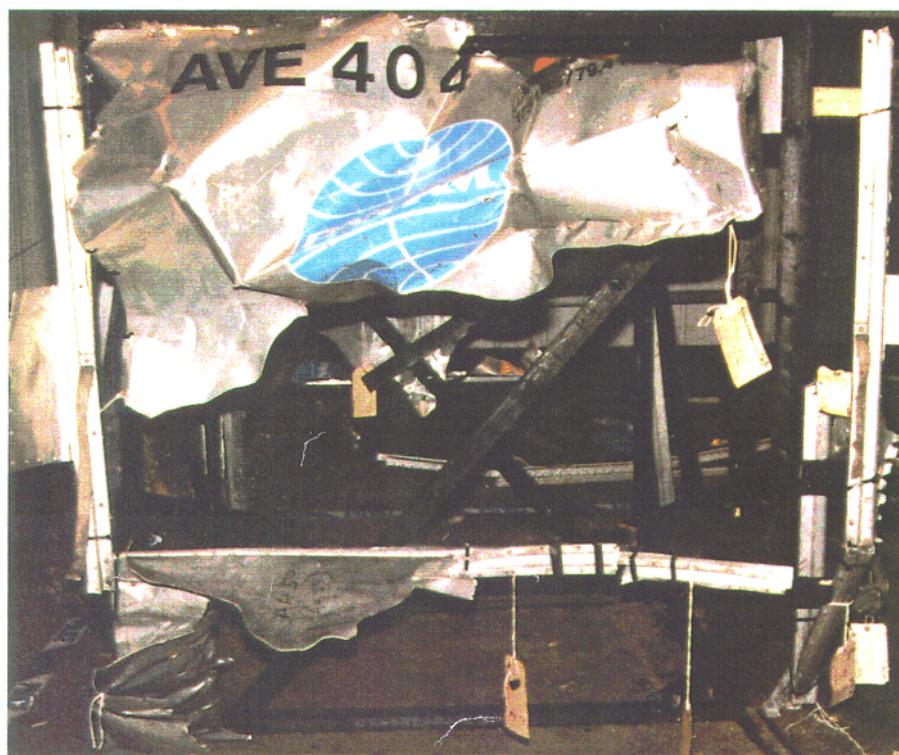
AG84 Stiffener section from base of vertical face

AH58 Vertical face forward edge member, lower stiffener section and skin fragment

AI31 Distorted upper section of vertical face skin

AI84 Forward section of sloping face skin, severely distorted

AI100 Fragment of container skin, **PROVISIONALLY** thought to be part of sloping face skin. Fragment exhibited some evidence of blast damage

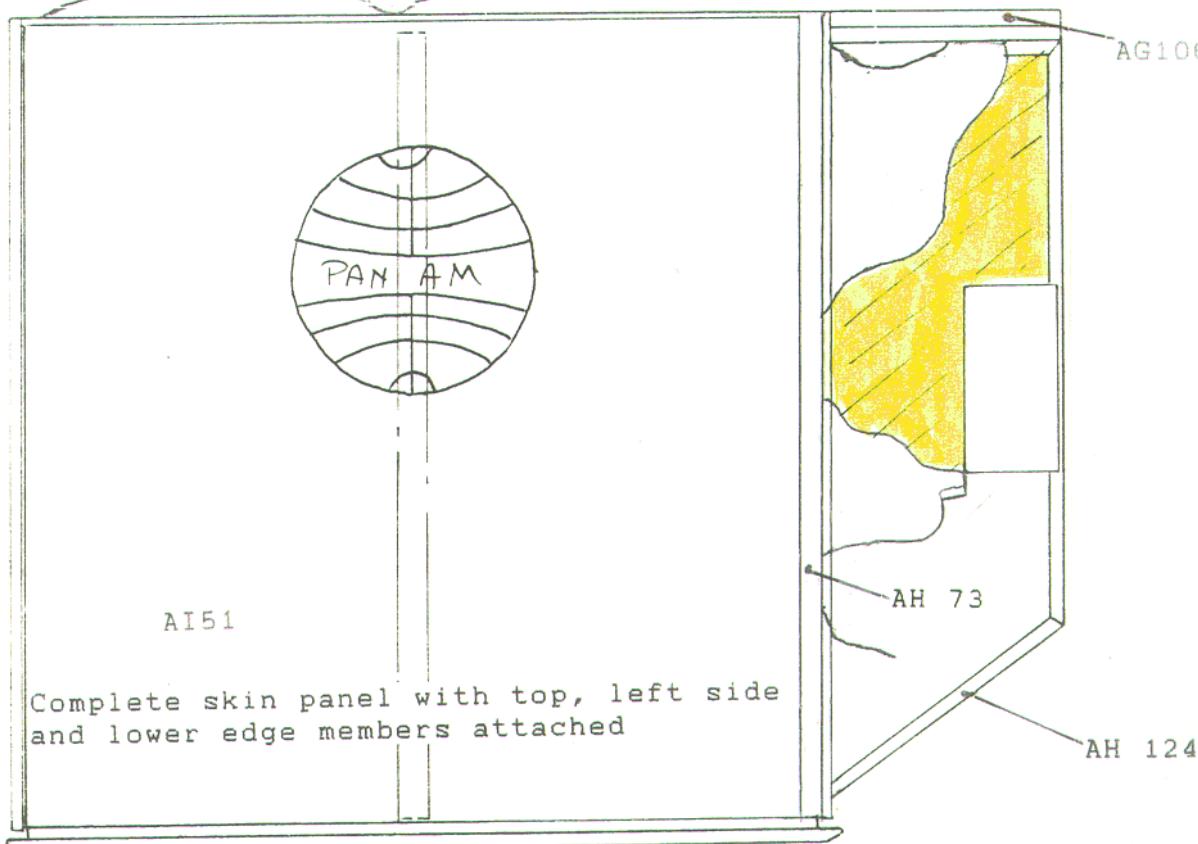
AG 106 Outboard section of roof edge member

AH 73 Forward face skin, outboard of AI 51, attached to vertical edge members from AI 51

AH 124 Forward edge member of sloping face

AI 177 Roof skin panel, complete except for aft outboard corner section approx. 2 ft by 1.5 ft.

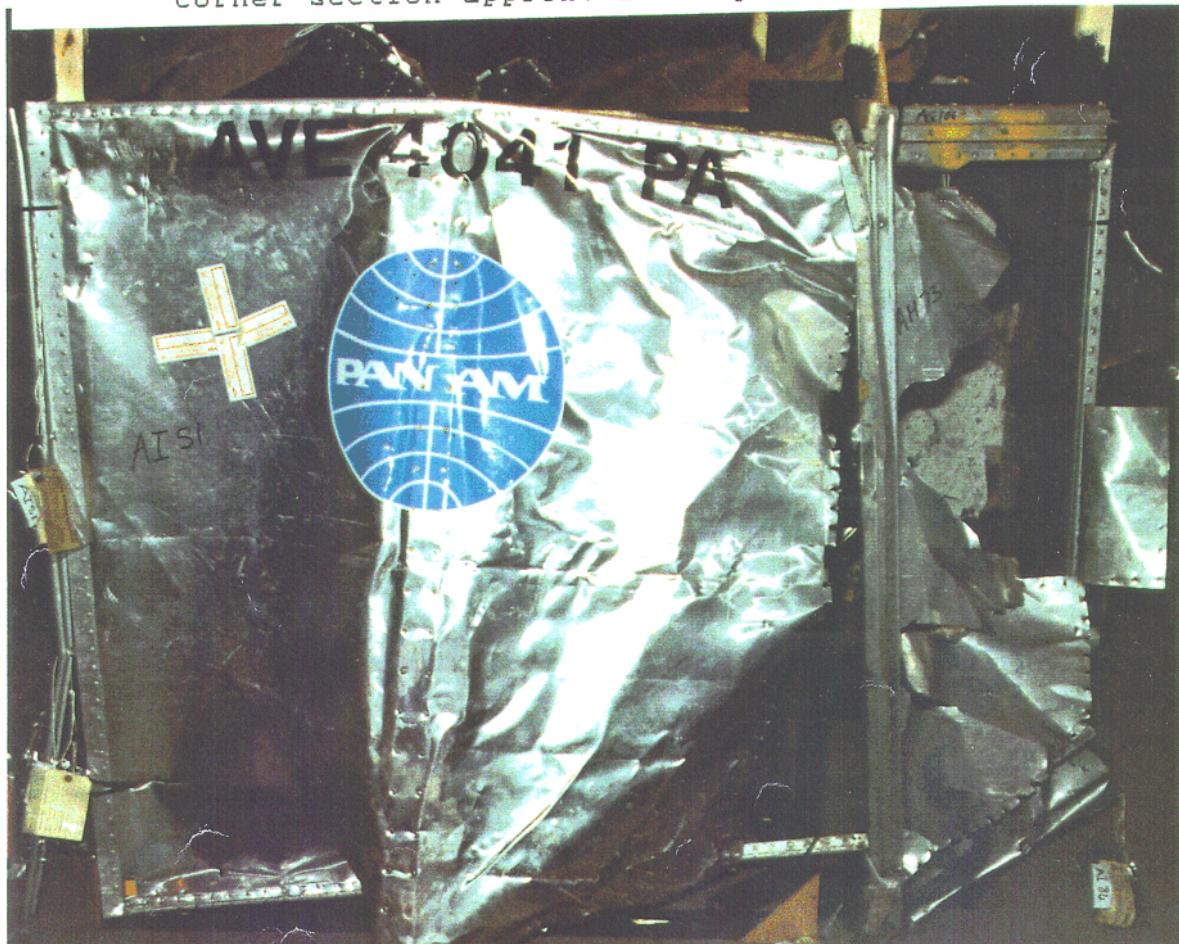
FIGURE 3.6

FORWARD FACE OF AVE 4041 PA, VIEW LOOKING AFT

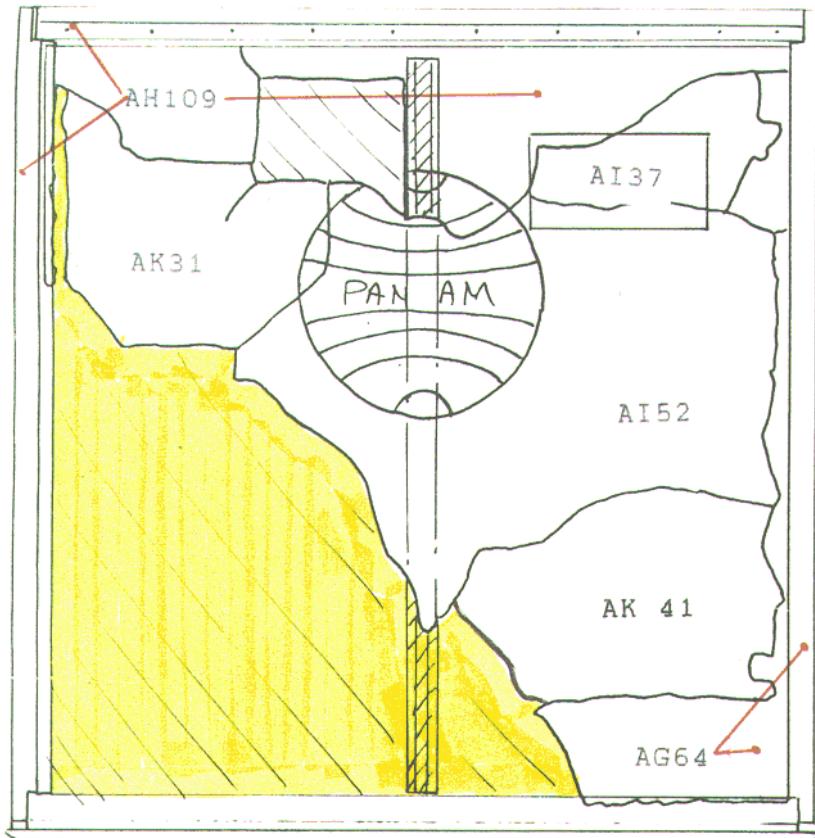
AH109 Aft, top and roof edge members including upper section of skin

AI37 Repair patch from upper right side

AI52 Mid section of skin including stiffener section

AK31 Upper skin section

AK 41 Lower skin section

AG64 Right side vertical edge member attached to lower piece of skin

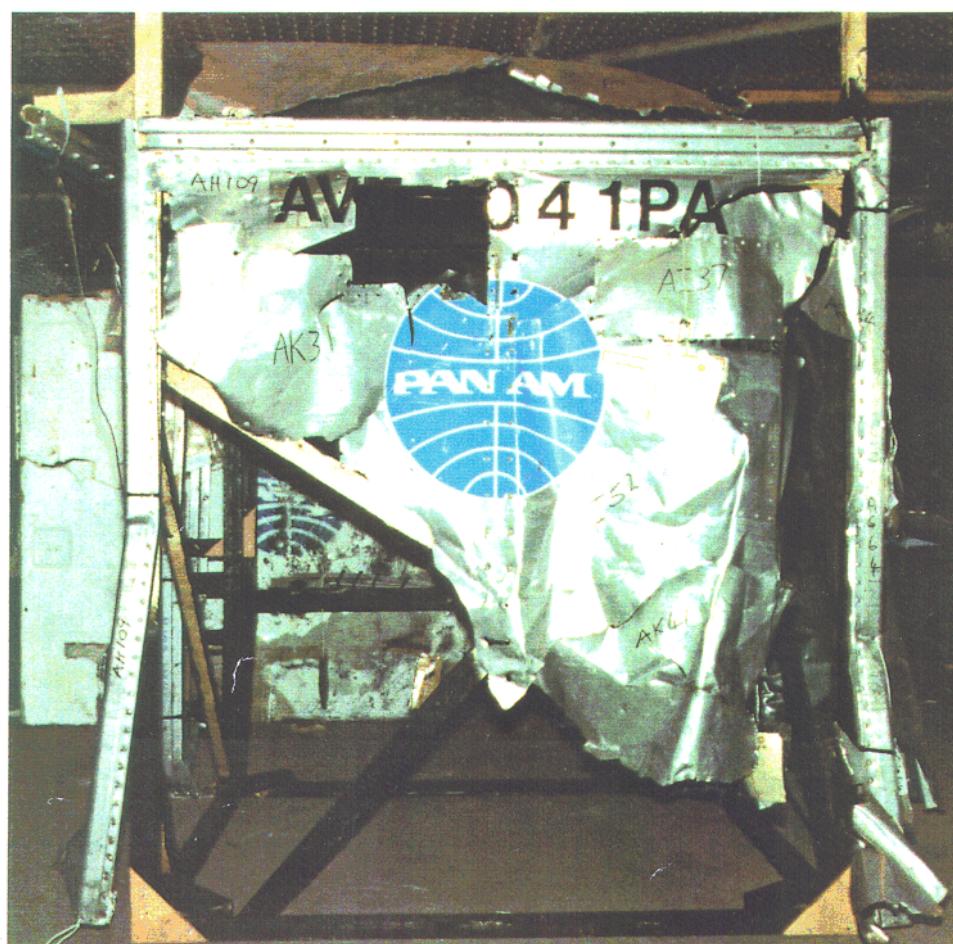
INBOARD FACE OF AVE 4041 PA, VIEW LOOKING OUTBOARD

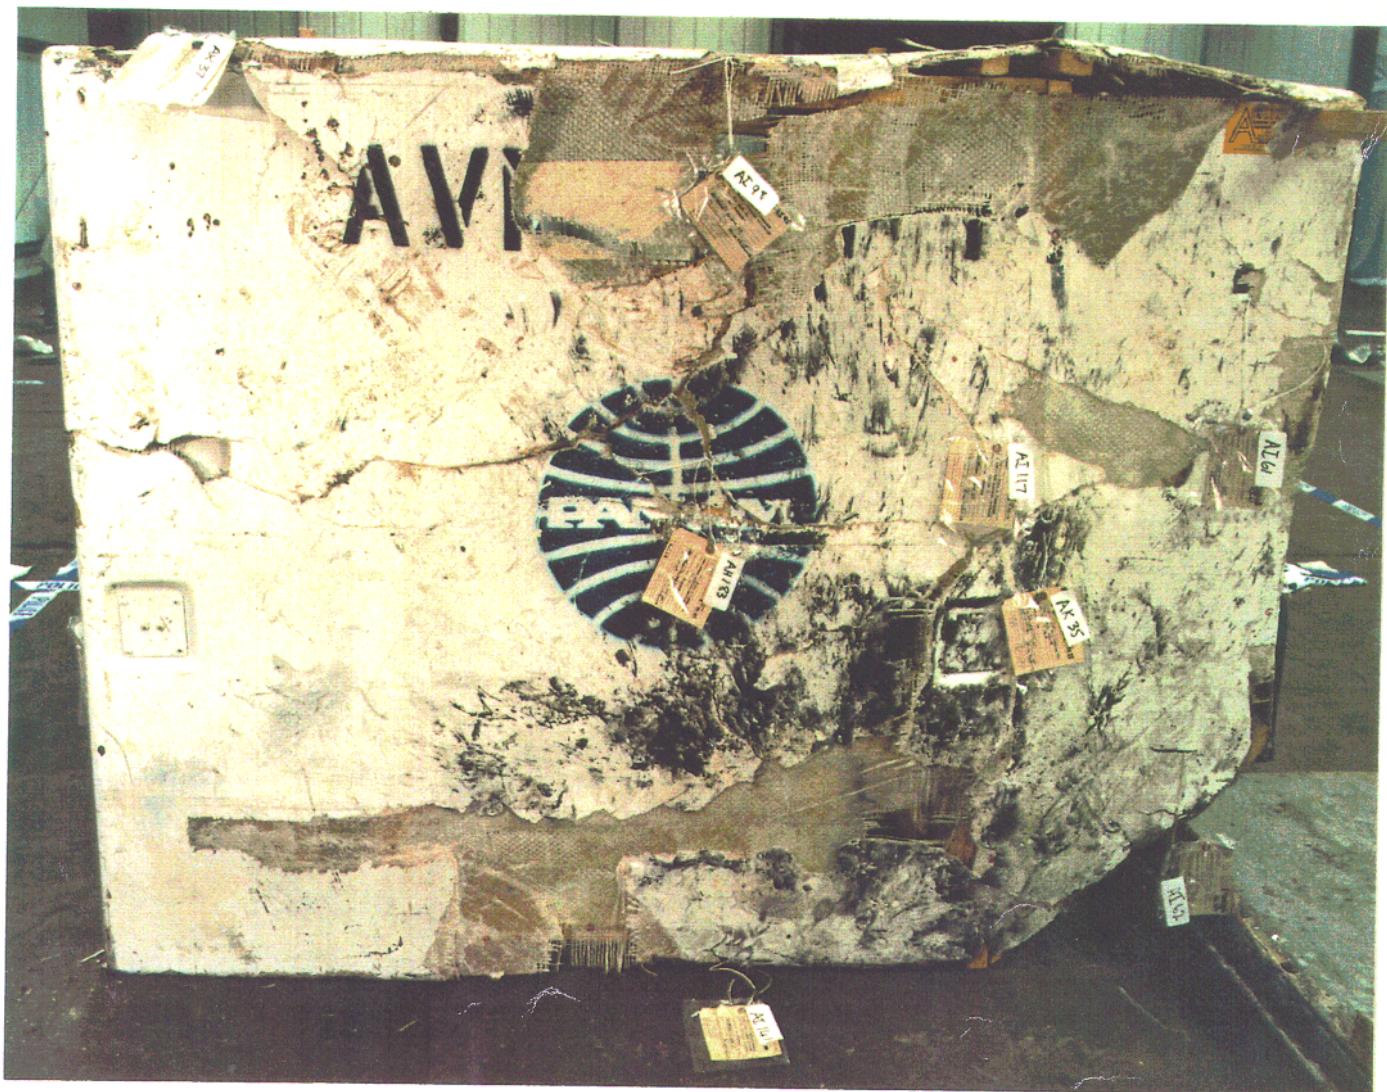
FIGURE 3.8

With the two container reconstructions placed together it became apparent that a relatively mild blast had exited 4041 through the rear lower face to the left of the curtain to impinge at an angle on the forward face of 7511. This had produced a hole approximately 8 inches square some 10 inches up from its base and removed the surface of this face inboard from the hole for some 50 inches. Radiating out from the hole were areas of sooting extending to the top of the container. Little signs were present of any similar damage on other external or internal faces of this or the immediately adjacent containers 14L, 14R or 21R.

Forward face of AVN 7511 PA, view looking aft

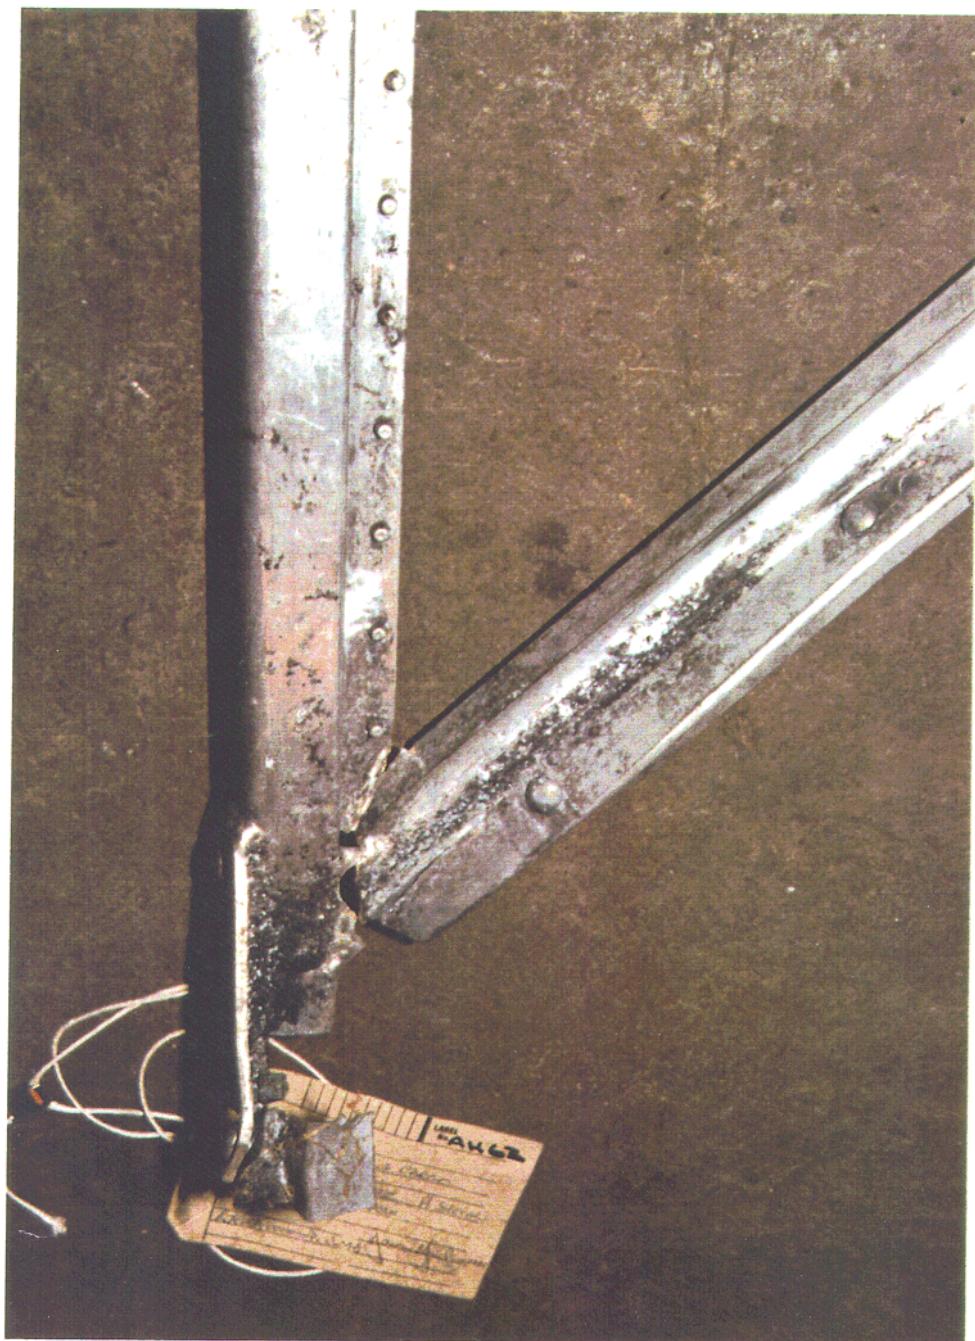
Detail of items AH63 and AG81 viewed from inside the container and showing evidence of blast damage

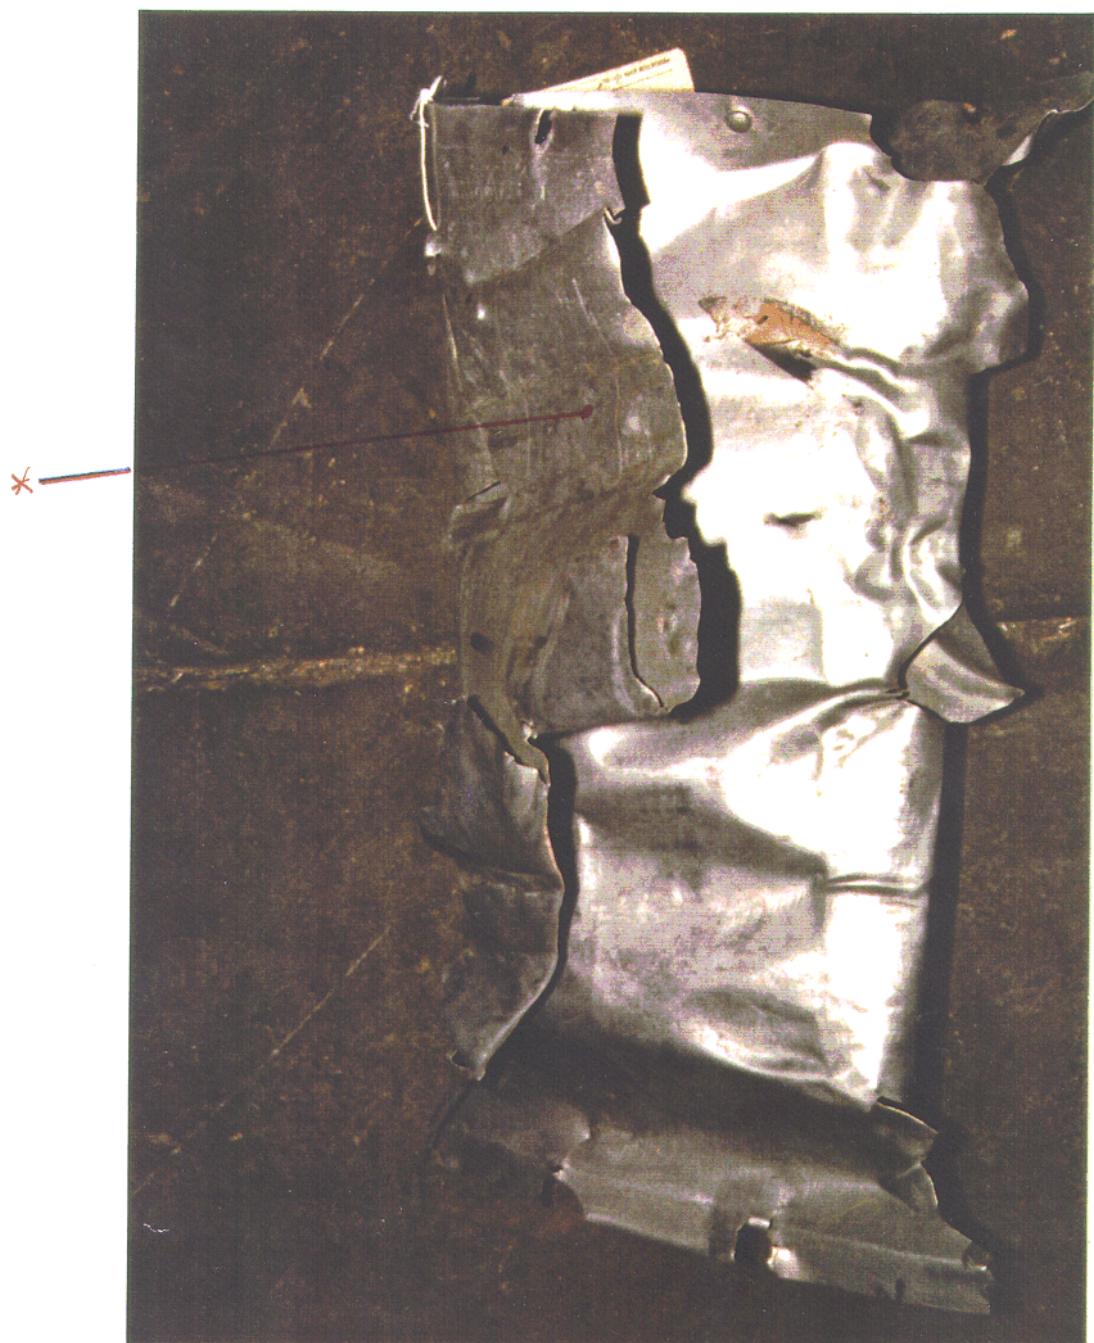
Detail of AI04, sloping face skin panel, showing severe distortion, double fold and imprint of fuselage stringer (S39L) on outer face *

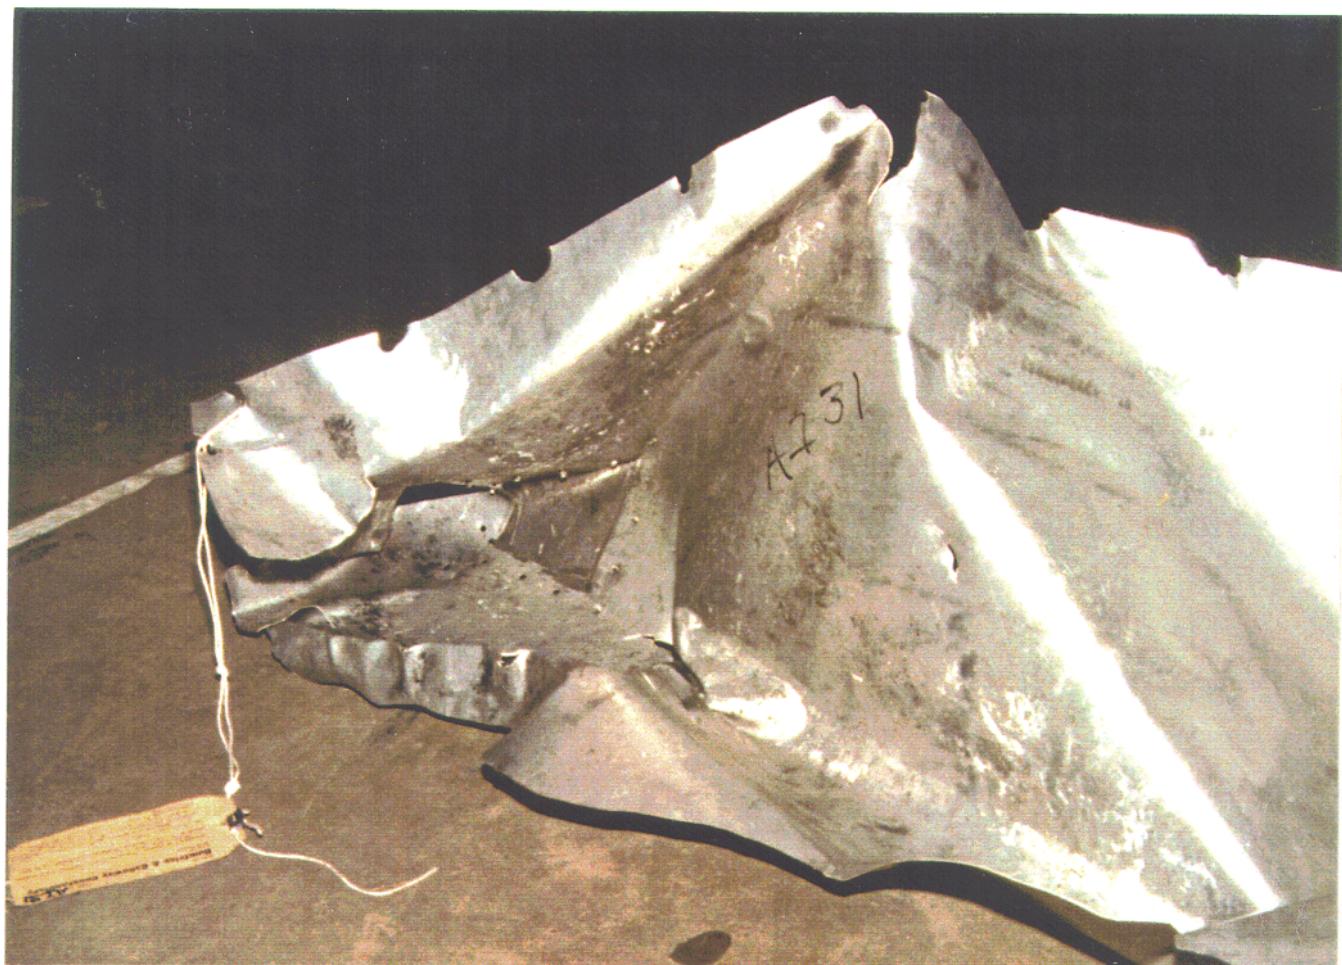
Detail of Al31 outboard face skin section, viewed from inside, and showing some evidence of blast damage and severe local distortion along its lower forward edge

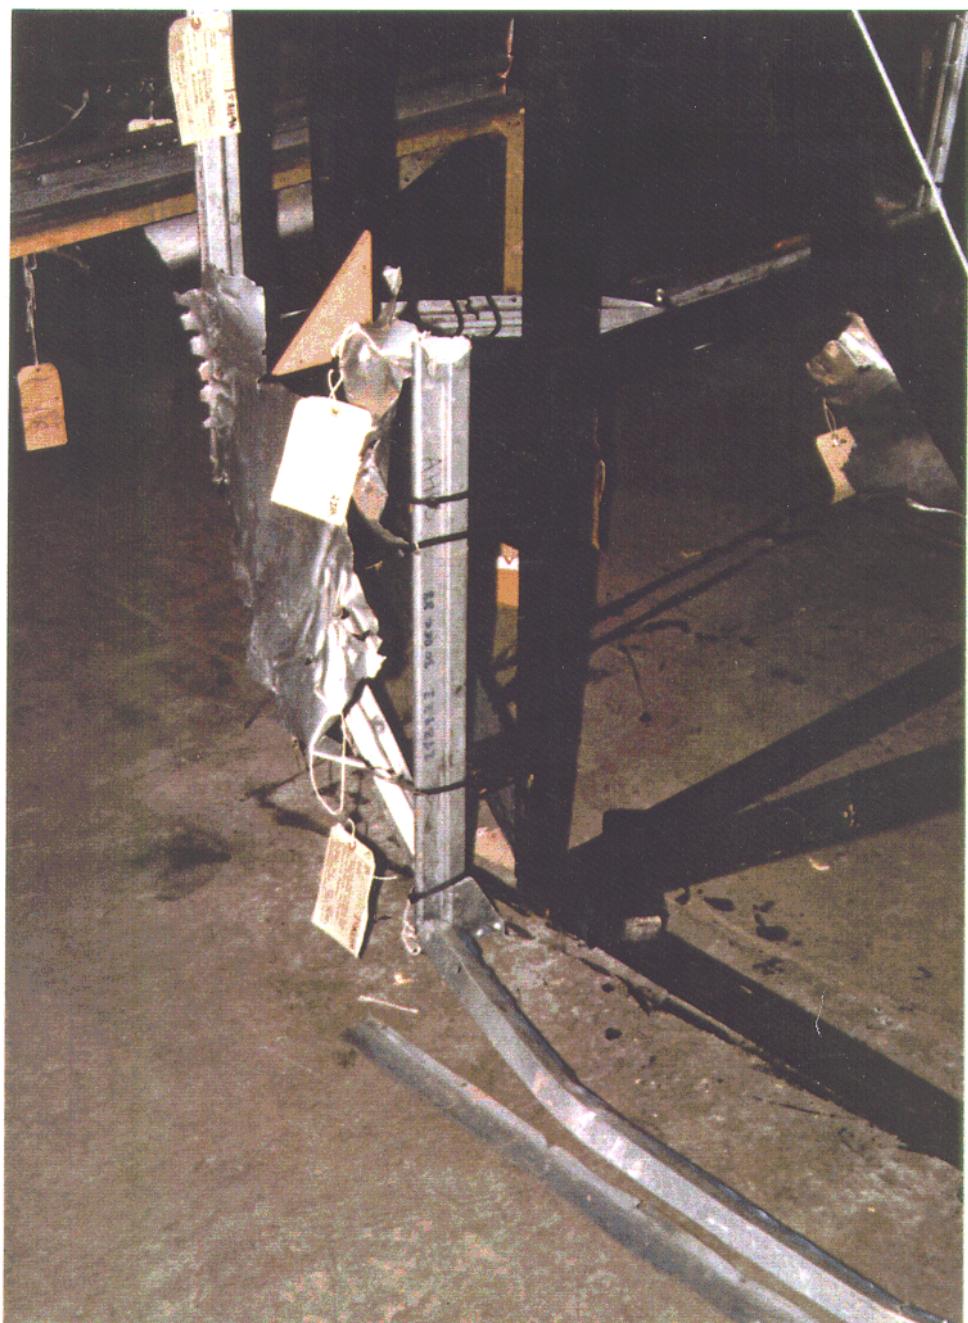
Detail of the container aft outboard corner showing blast damage to the lower skin panel and outward distortion of the lower curtain bar. To date none of the curtain itself has been recovered

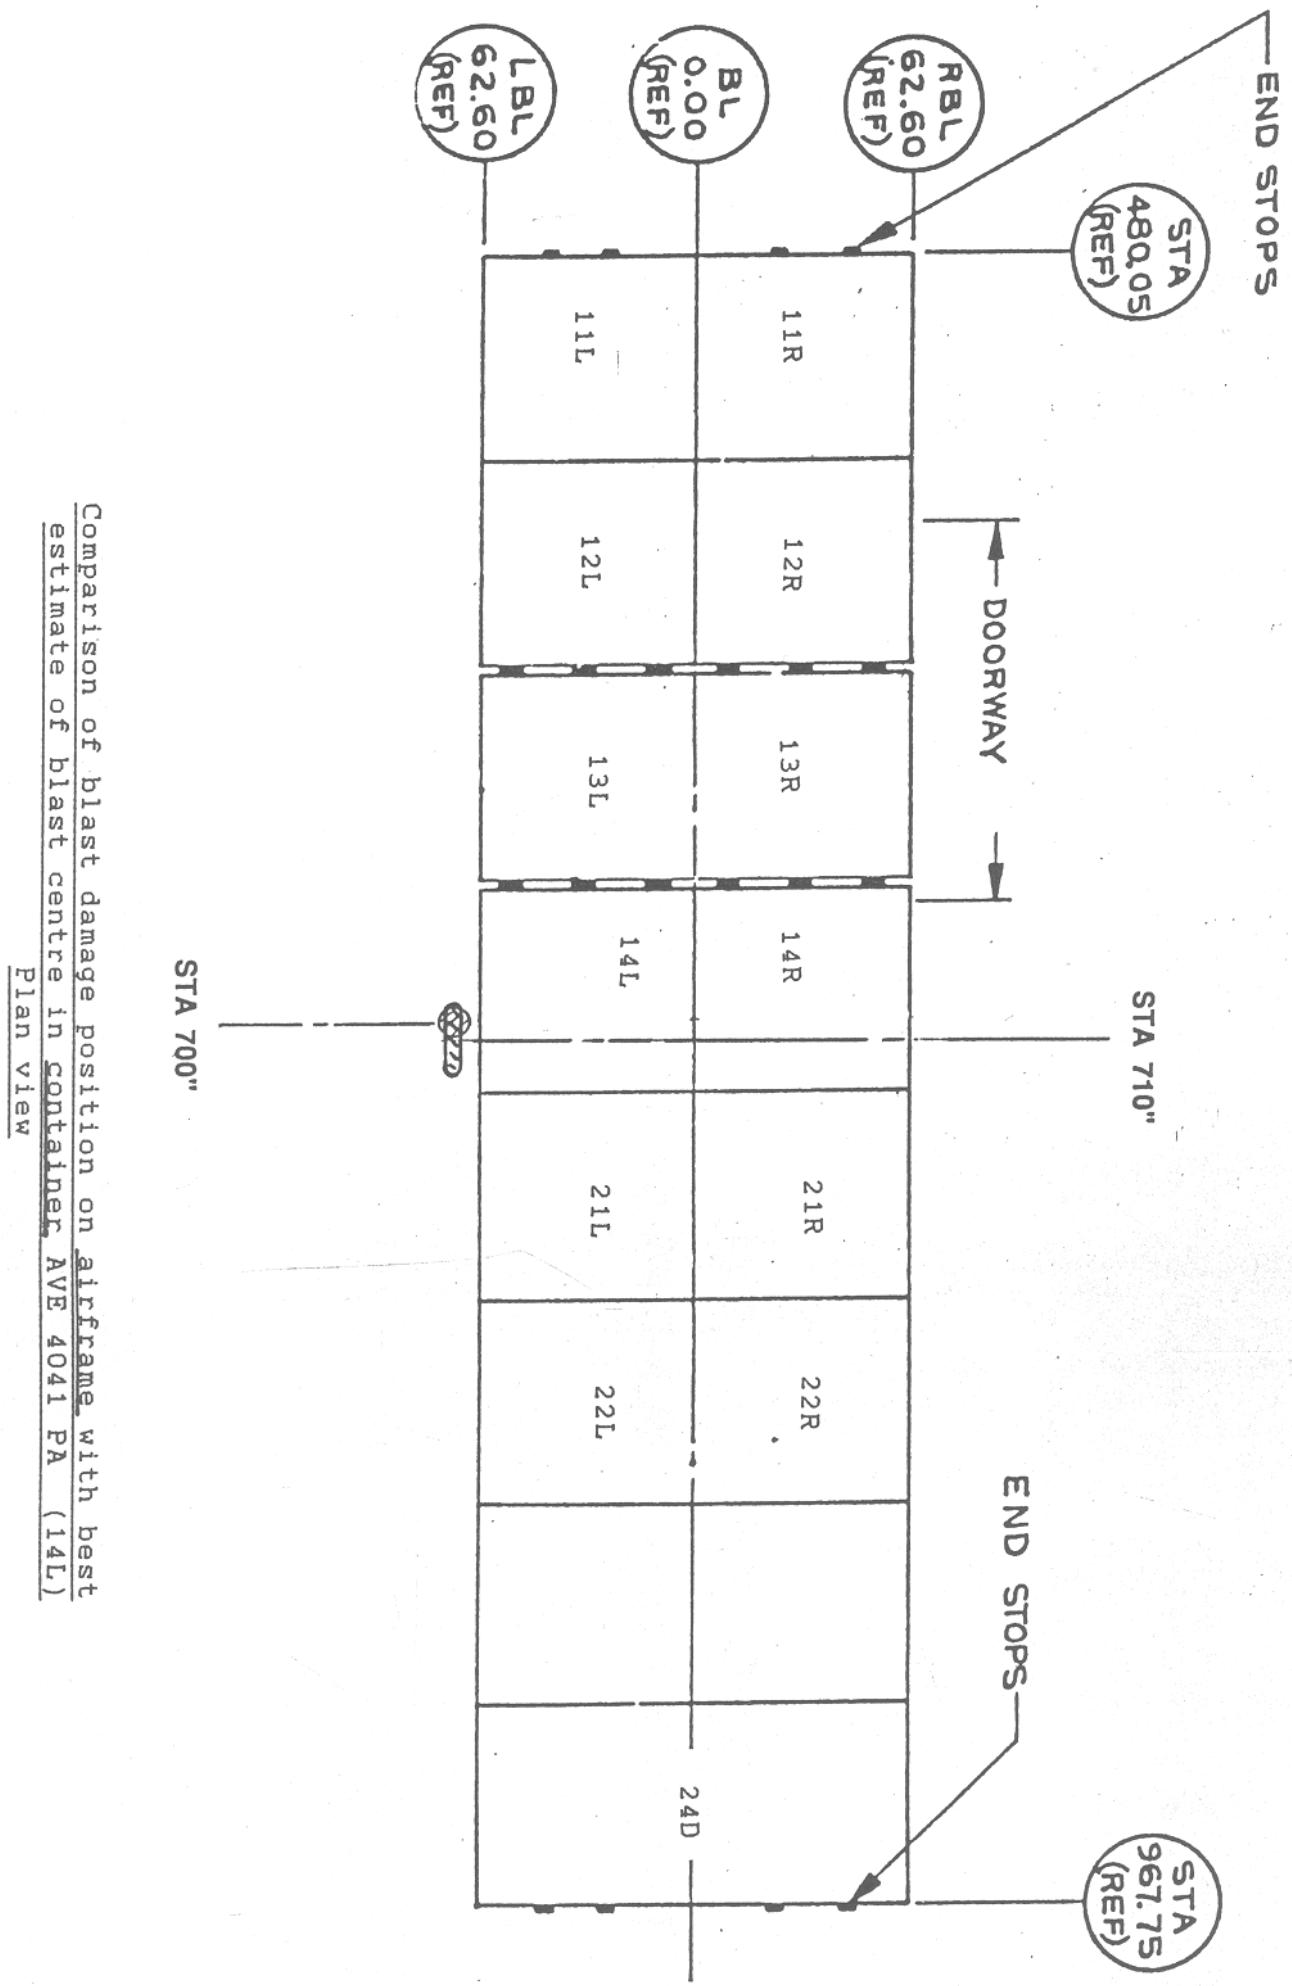
The general character of damage that could be seen, following the reconstructions, to the aft outboard lower quarter of container AVE 4014 PA and the forward face of AVN7511PA was of a type not seen on any of the other container wreckage. In particular, the reconstruction of the floor of 4041 revealed a localised area of severe distortion and tearing which, with preliminary results from RARDE's examination of the floor's outboard edge member (which established that this component had been damaged by a 'detonating high explosive'), left little doubt that a device had exploded within this container. Assessment of the distortion to the left container skin and its lower stiffener section, the angled face skin, aft face skin and structure to the left of the access aperture indicated that the likely lateral position of the device was as shown in figure 5. In a longitudinal sense this same centre is assessed as being at station 705" on the aircraft structure. The best assessment of this position within container 4041 would seem to be approximately half way between its aft face and the mid point of the container. Figure 6 is a plan view showing the positions that containers 4041 and 7511 would normally adopt in the cargo hold, and shows a close proximity between the blast

damaged area on the airframe and the estimated position of the device in 4041.

Comparison of blast damage position on airframe with best estimate of blast centre in container AVE 4041 PA (14L)
Plan view

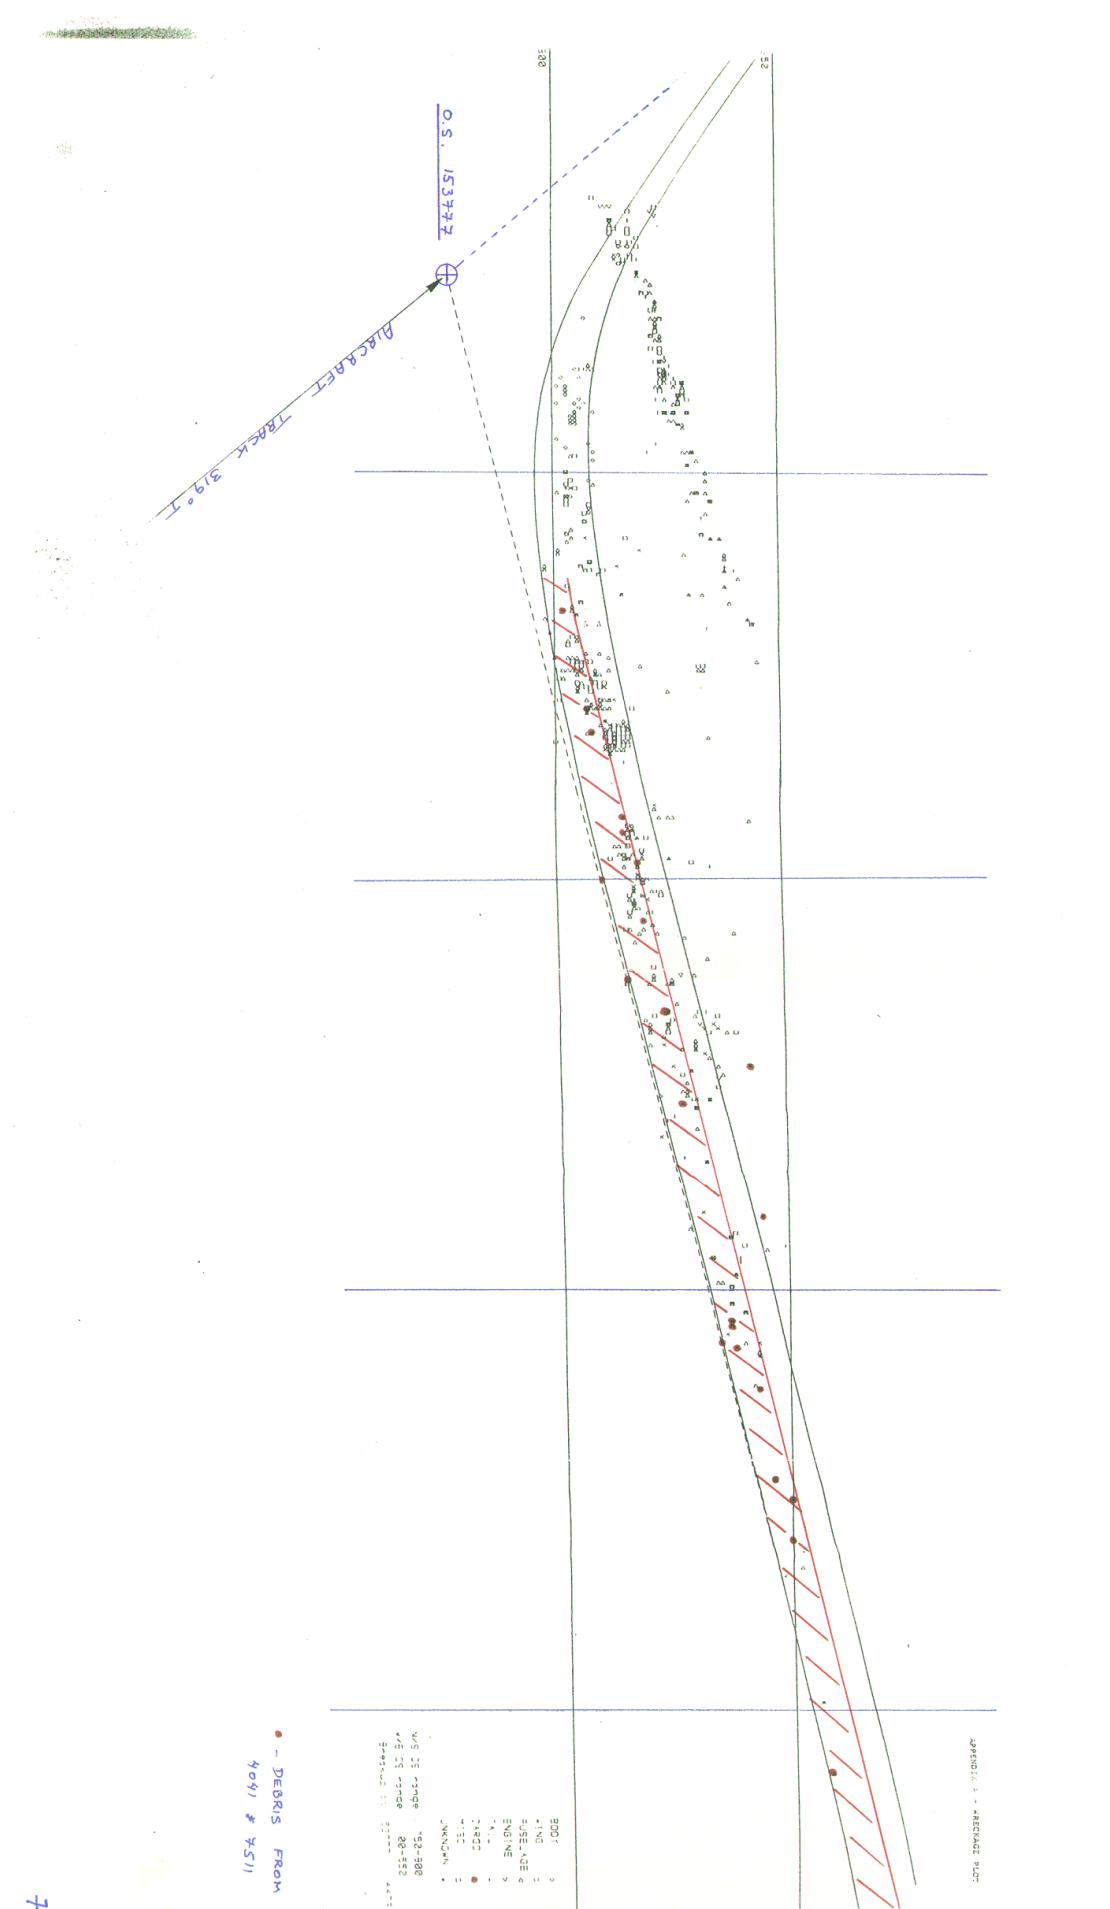
Figure 7 shows the distribution across the ground of most of the items used in the reconstruction of containers 4041 and 7511. As may be seen, this trail is mainly confined to the southern edge of the main wreckage southern trail. With reference to the wind drift and wreckage plot report (CIT), this distribution would seem to confirm the belief that one of the early events in the aircraft break-up sequence was the blast damage to and ejection of (at least) these two containers.

• - DEBRIS FROM 4041 # 4511
