ACCIDENT TO PAN-AM BOEING 747 N739PA AT LOCKERBIE ON 21 DECEMBER 1988

Baggage Container Examination

P T Claiden

April 1989

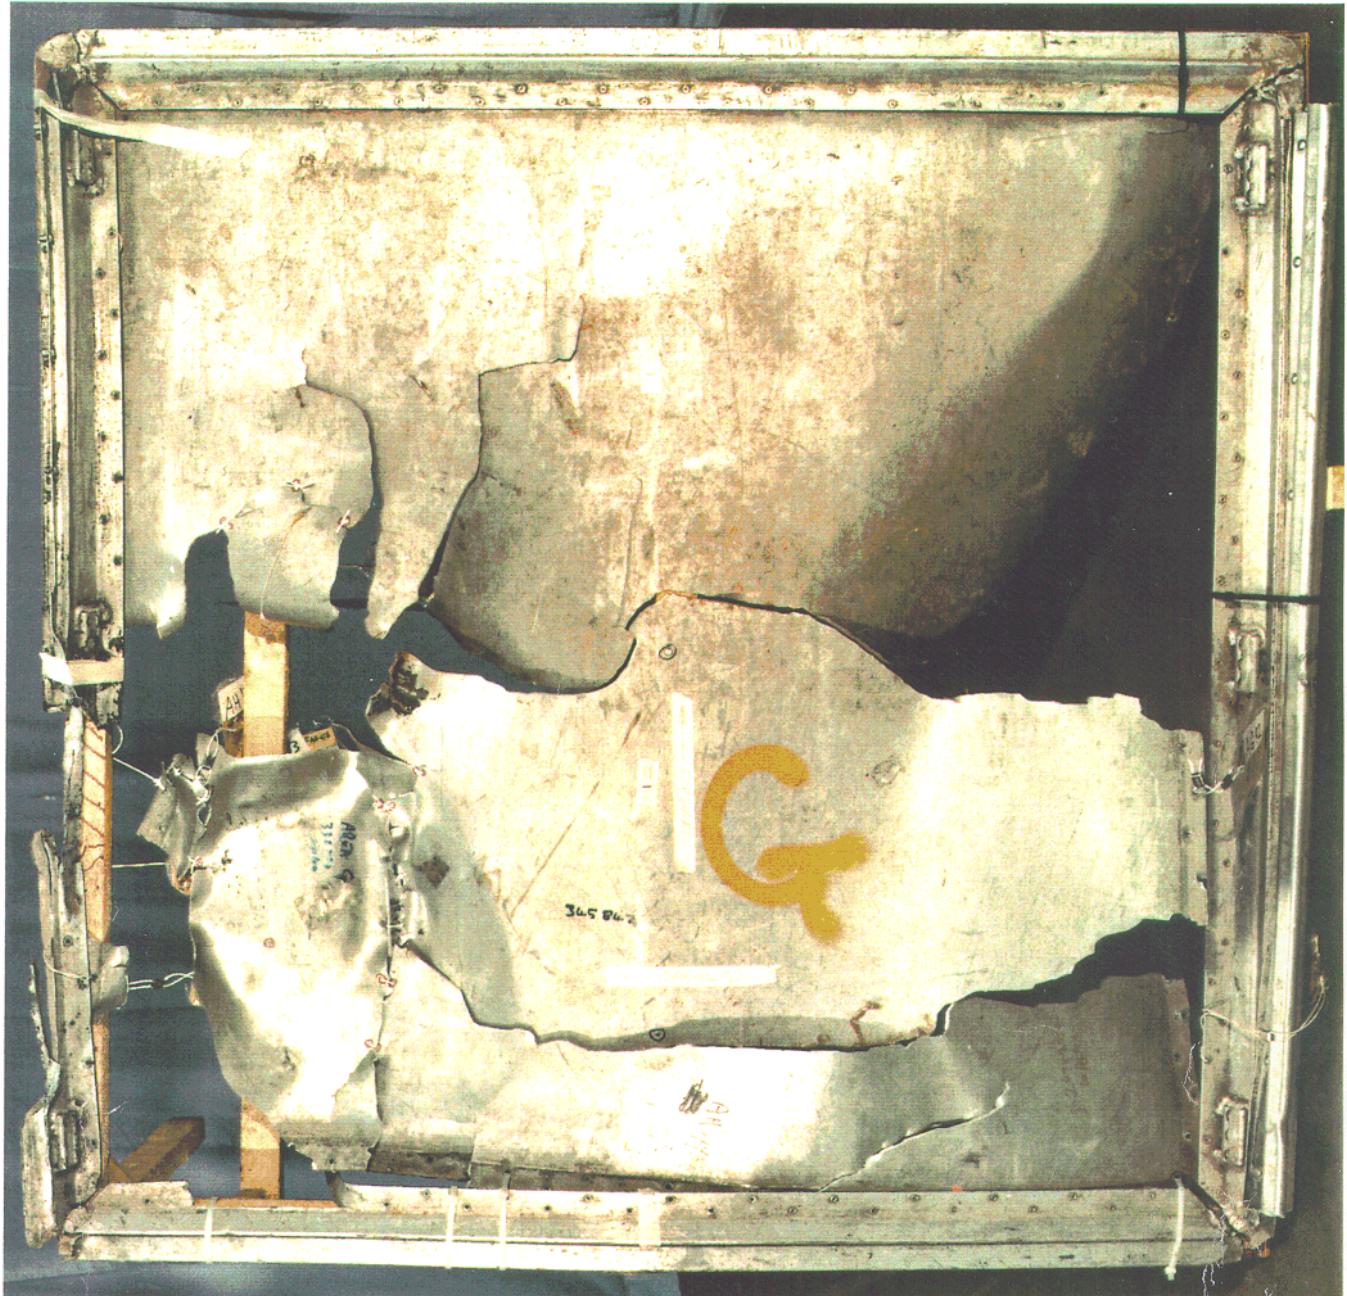
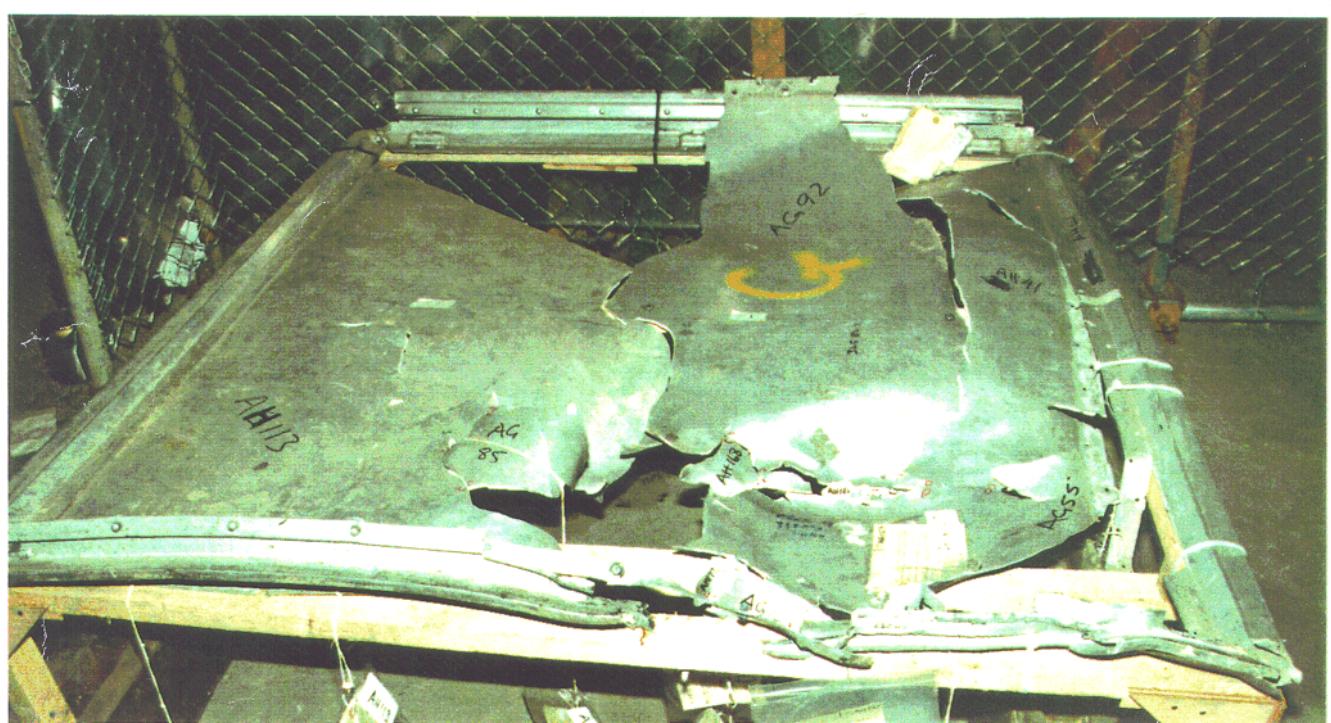
FIGURE 3.2

AG 152 Forward section of blast damaged outboard edge member

AG 151 Aft section of blast damaged outboard edge member

AH 237 Blast damaged fragment from AG 151

AG 107 Floor fragment associated with AG 151

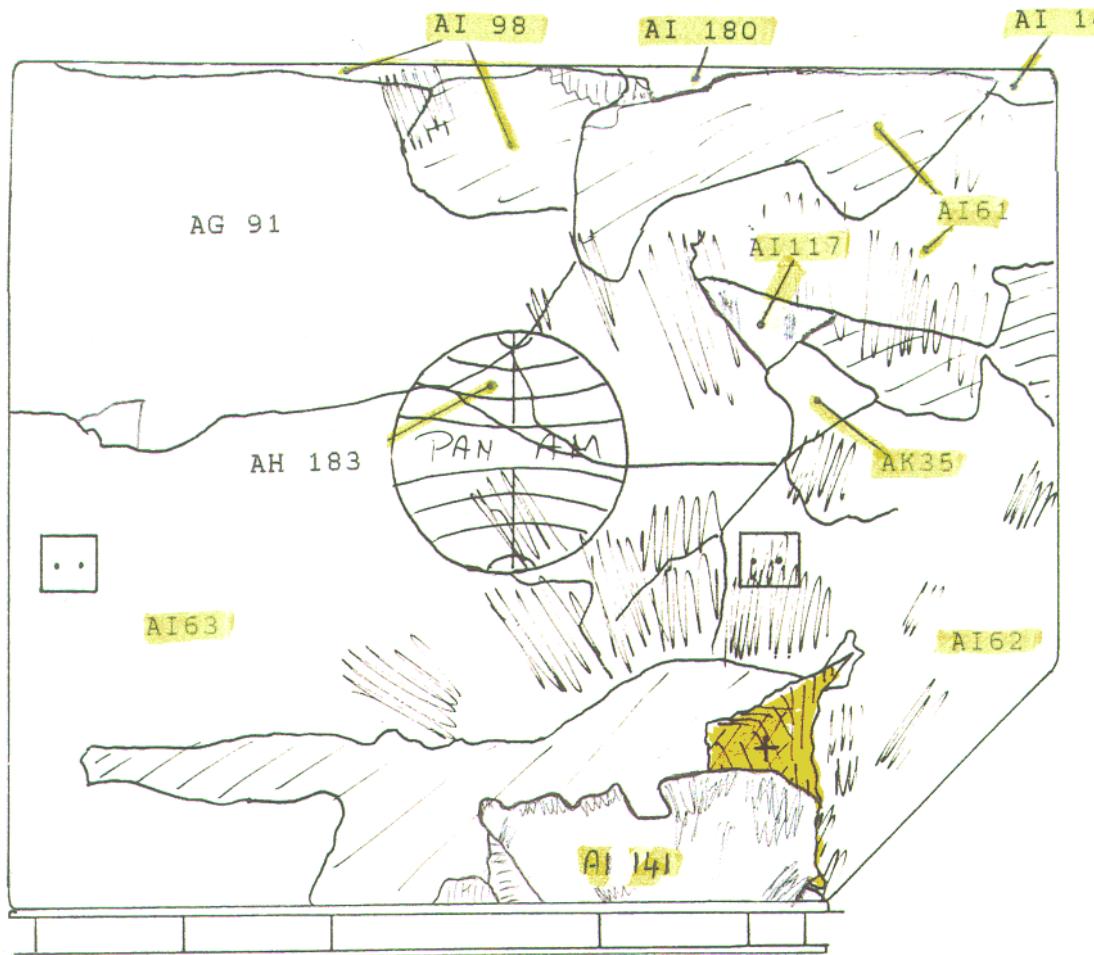
FIGURE 3.8

Forward face of AVN 7511 PA, view looking aft
